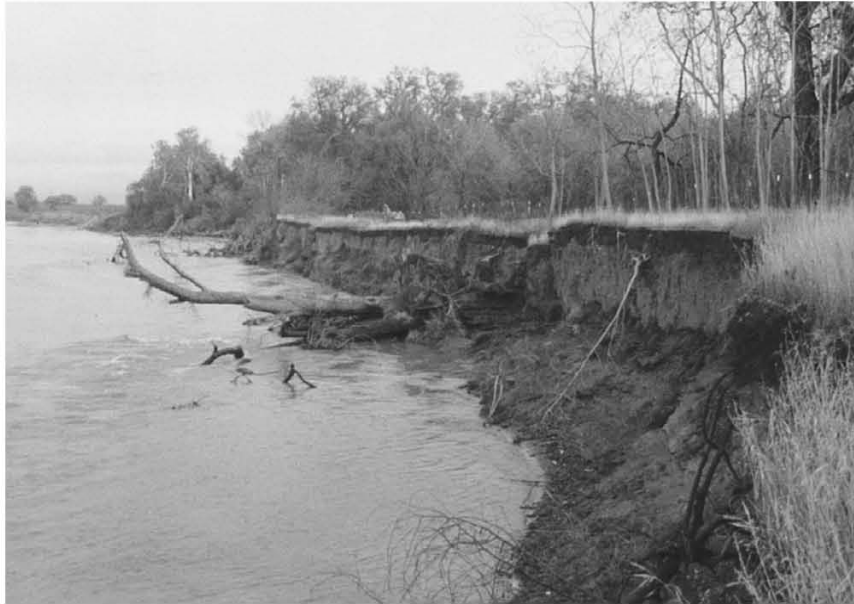
Figure 2.8. Active bank erosion illustrated by vertical cut banks, slump blocks, and falling vegetation.

Active bank erosion can be recognized by falling or fallen vegetation along the bank line, cracks along the bank surface, slump blocks, deflected flow patterns adjacent to the bank line, live vegetation in the flow, increased turbidity, fresh vertical faces, newly formed bars immediately downstream of the eroding area, and, in some locations, a deep scour pool adjacent to the toe of the bank. These indications of active bank erosion can be noted in the field and on stereoscopic pairs of aerial photographs. Color infrared photography is particularly useful in detecting most of the indicators listed above, especially differences in turbidity.⁽¹⁶⁾ Figure 2.8 illustrates some of the features which indicate that a bank line is actively eroding.
